PROGRESS ENERGY: SPILL PREVENTION, CONTROL & COUNTERMEASURE PLAN

Re: Carolina Power & Light Company d/b/a Progress Energy Carolinas, Inc.
Information Submittal Under 40 CFR §112.4
Spill Prevention, Control, and Countermeasure Plan

Wake 500 kV Transmission Substation

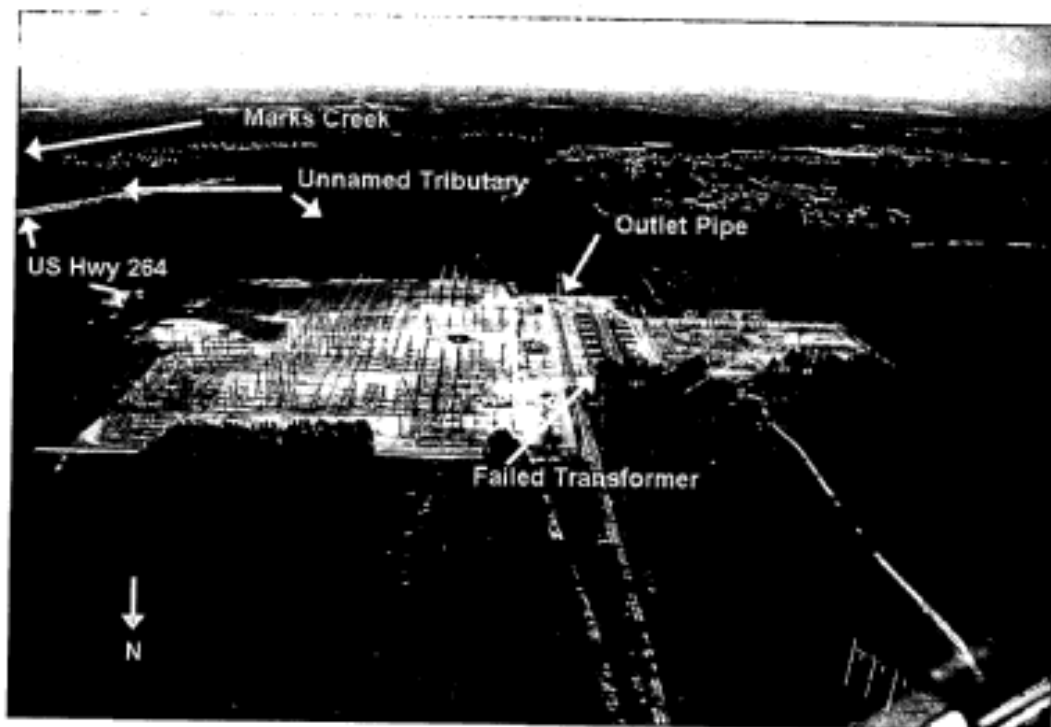
Attachment A-1. Wake 500kV Substation, showing general layout of facilities and natural features. [Note: Surface water flow direction is generally to the southeast.]

The facility is a 500 kV transmission substation, energized and put into service in May 1972. The substation contains oil-filled electrical equipment with mineral oil as a dielectric fluid. As noted previously, the total capacity at the facility is 196,800 gallons. The approximate extent of the oil spill is shown in Attachment A-12 and an aerial view of the substation is shown in Attachment A-1.

maintenance personnel were dispatched to the site and arrived on the scene at 0830 hours. They observed that the transformer tank was compromised on the top and along the sides, allowing oil to exit the transformer (Attachment A-13). Additional Progress Energy Carolinas maintenance personnel were summoned to the site and began to boom off visible oil, the majority of which was located north and east of the transformer. The discharge to water occurred when oil entered an underground pipe that was not identified on the facility diagram included with the facility's Spill Prevention, Control and Countermeasure Plan. This underground pipe allowed oil to leave the site on the south side of the substation approximately 550 feet from the failed transformer (Attachment A-1).

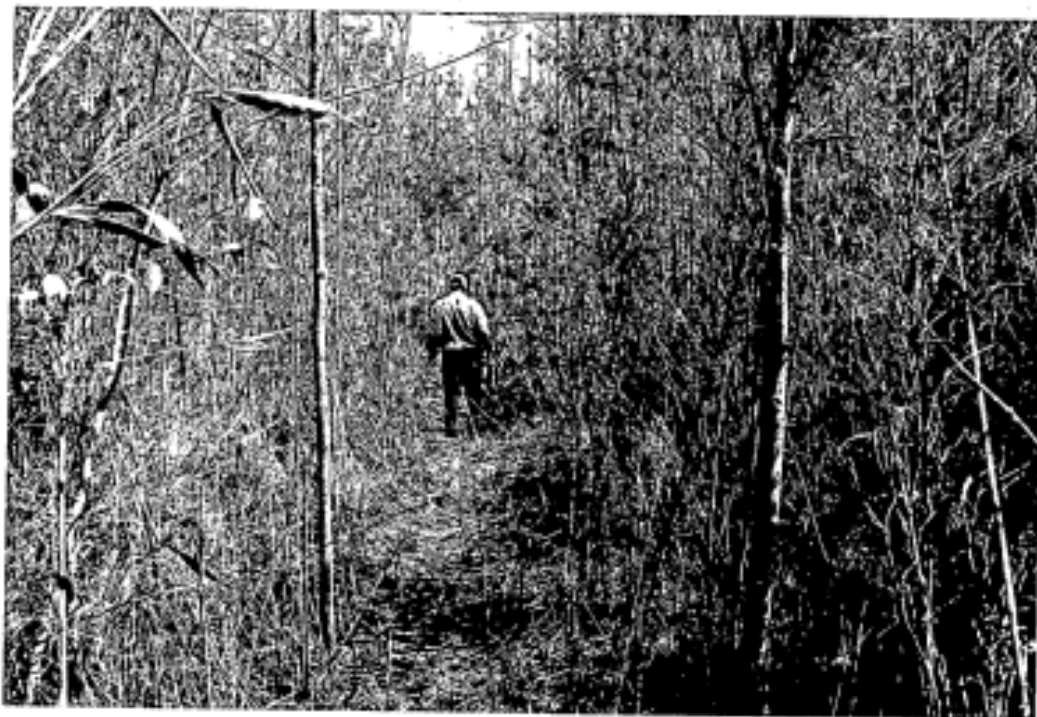
Attachment A-6. Representative riparian vegetation, showing access difficulty, on portions of the unnamed tributary to Marks Creek.

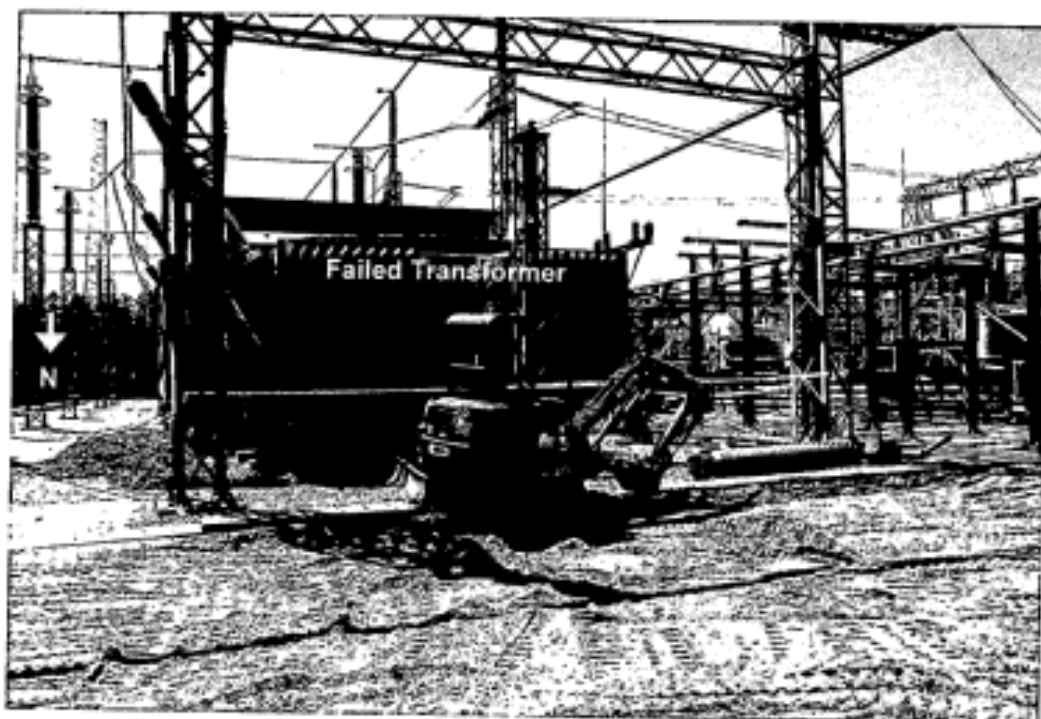
Attachment A-7. Failed transformer in Wake 500kV Substation, and initial soil cleanup.

Free product recovery and impacted soil removal (from the substation) (Attachments A-7 and A-8) continued on a 7 day/week basis. Efforts to further segment the affected areas included the placement of booms in four additional locations. Where possible, product recovery methods consisted of pumping oil from in front of weirs and booms. For the majority of the area downstream of US Hwy 264, due to limited access, recovery methods consisted of manual placement and recovery of pads and booms (Attachments A-9 and A-10).

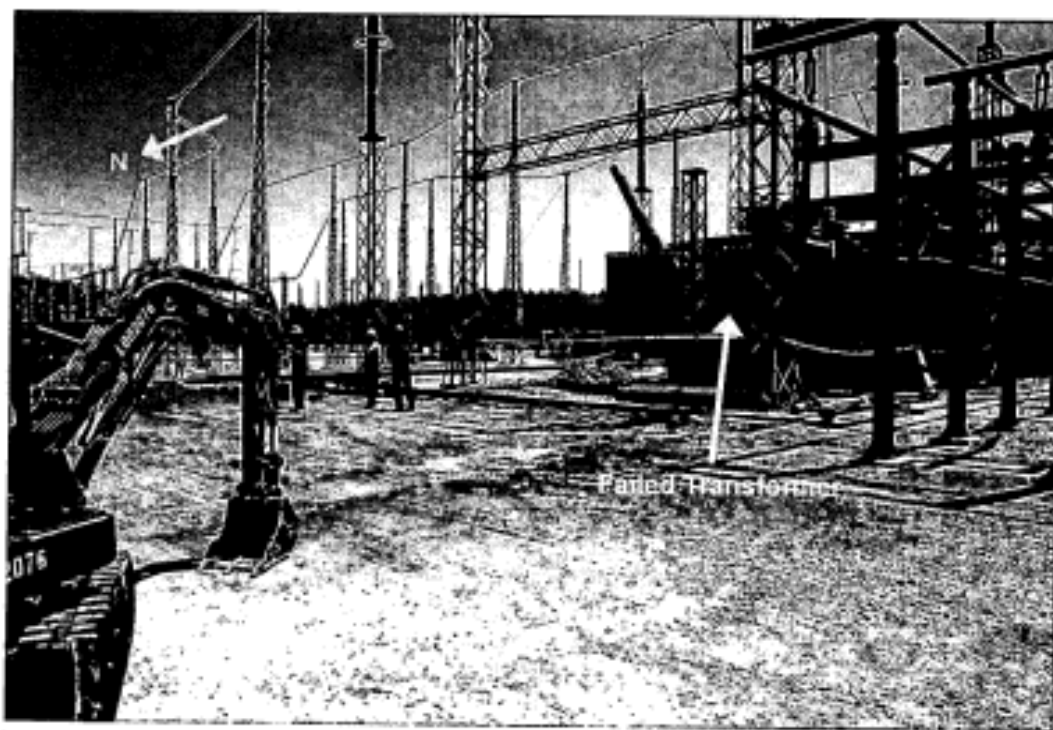
Attachment A-8. Failed transformer in Wake 500kV Substation, and initial soil cleanup.

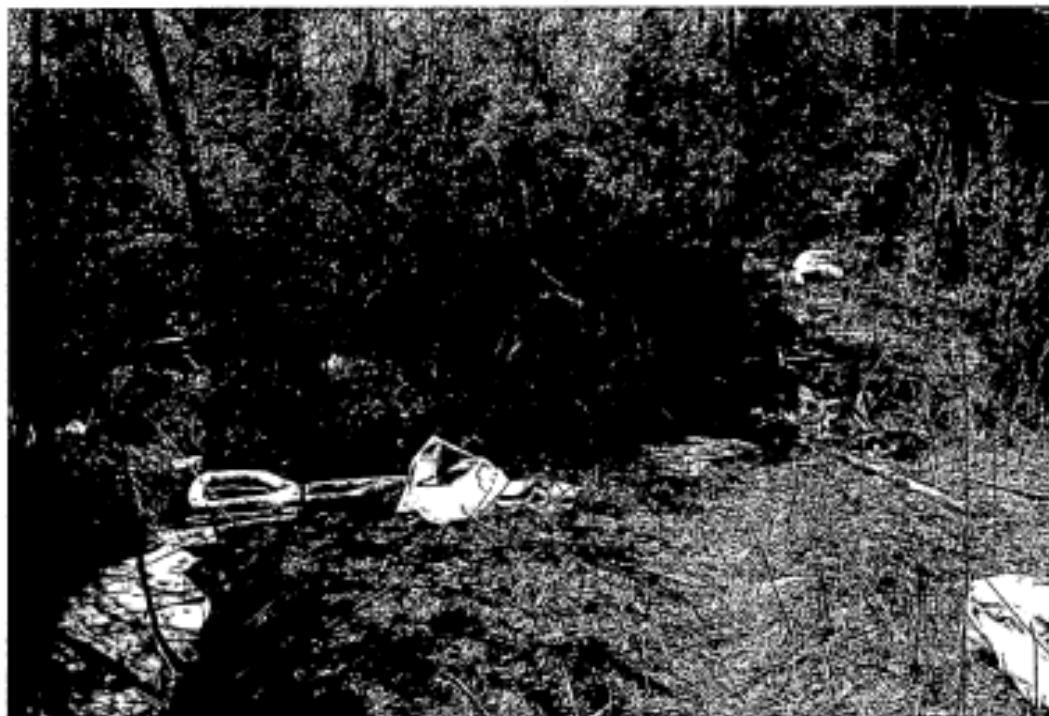
Attachment A-10. Absorbent pads and booms in place on unnamed tributary of Marks Creek.

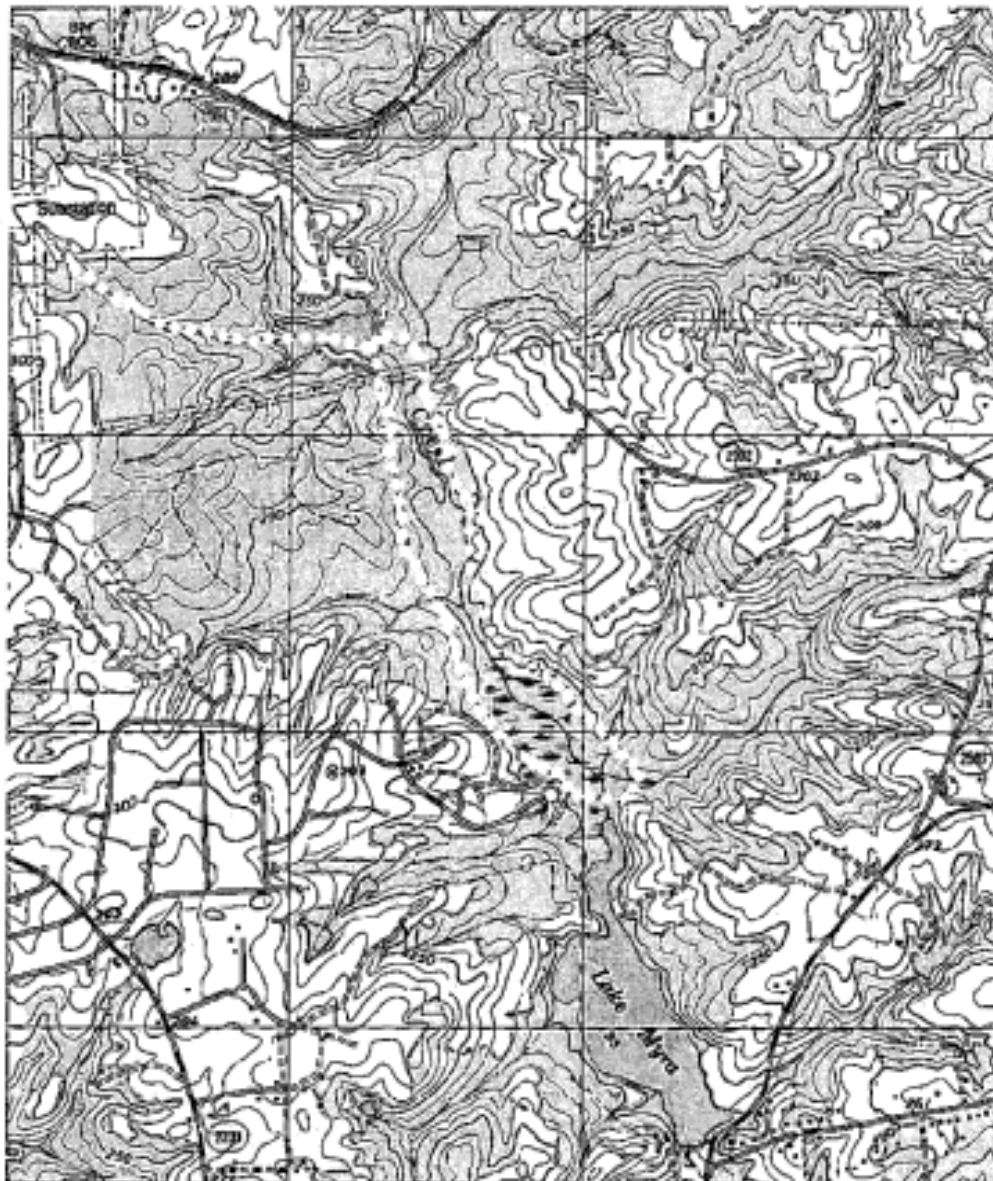
Attachment A-12. Topographic map showing approximate extent of Wake 500kV substation oil spill (Knightdale Quadrangle, North Carolina, Wake County, USGS, 2002).
